## **ROCKFALL HAZARDS ALONG ABURI-ACCRA ROAD, GHANA**

Prescilla Ofosu Dankyi, Professor Laud A. Dei, Professor Benjamin K. Nyarko

Faculty of Social Science, Department of Geography and Regional Planning,  
University of Cape Coast, Ghana.

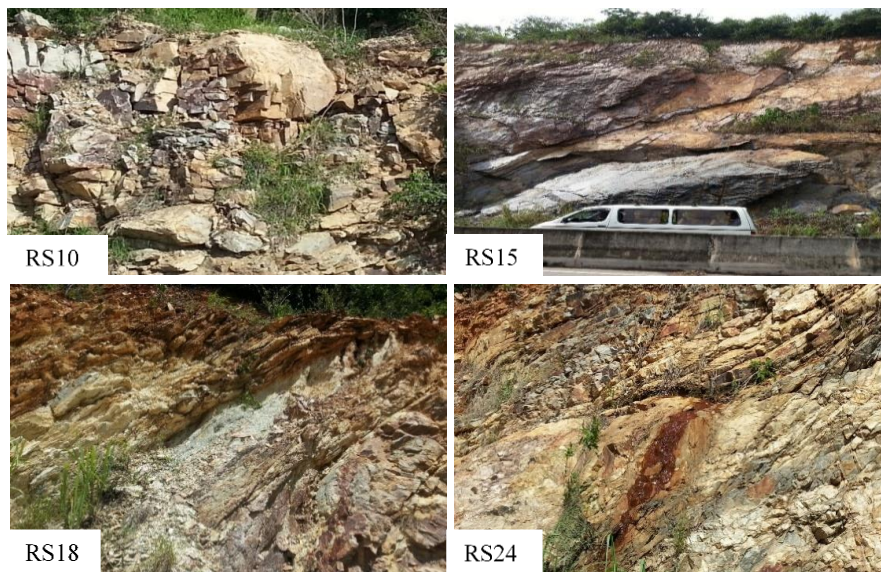
**Figure 3. Nature of distinct joints on slope face**  
**Source: Field data (2016)**

As shown in Figure 3, rocks on RS10 were heavily crushed by gradual movements overtime and previous disturbances. Hence it is characterized by several random joints. Also, there were several random joints on RS10 while RS15 had few of these features. On RS18 weathering had exposed two schist shear zones. Water was also seen seeping through a zone of weakness in RS24. These highly fractured rocks are likely to slide and fall. On the other hand, RS15 had distinct joints and a few random cracks. As shown in Figure 3, the intersection of two joints was facilitating the removal of a huge slab, an event which was said to have occurred about two years ago. Presently, this rock has been removed. Furthermore, weathering along the slope face of RS18 had exposed two schist shear zones across a bench. These are features which could be made up of deformed weathered rocks within a rock mass (Renato, 2018). These features are distinguished by sudden variation in colour (Jamaluddin & Deraman, 2000) from light to dark reddish zones are made up of schist. It was also observed that weathered schist from these zones gradually piled up beneath these features. The presence of these joints increase the exposure of the rock mass to physical and chemical weathering.

Duku (2015) indicated that quartzite are permeable by water when fractured. Observations made indicated that out of the 5 sites where water seeped through zones of weakness, all sites were made up of quartzite. One of such sites was RS24. Water was seen seeping through a zone of weakness in this site. Seepage of water on slope face during the wet season leaves behind water streaks when dried as shown in Figure 3.

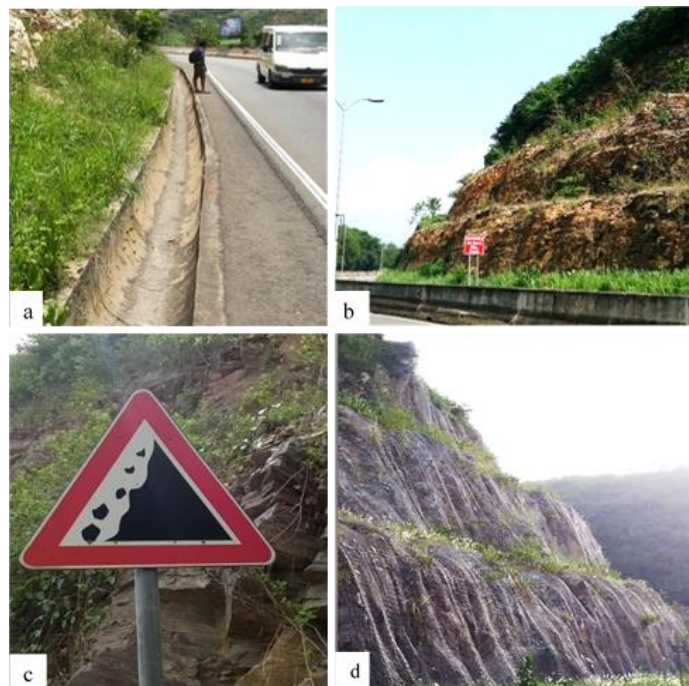
**Figure 4. Rock fall Adaptation measures along the Peduase-Ayi Mensa road**  
a) ditch and drain b) benches c) rock fall warning signs d) installed wire mesh  
Source: Field data (2017)

Observations made during the field studies revealed that anticipation of these movements led to the provision of adaptation measures which include the placing of warning signs at vantage points and construction of ditch and drain along the entire road. Benches were constructed at RS18, 30, 31 and 32. Furthermore, a respondent indicated that inhabitants go to clean rock fragments on the road periodically.

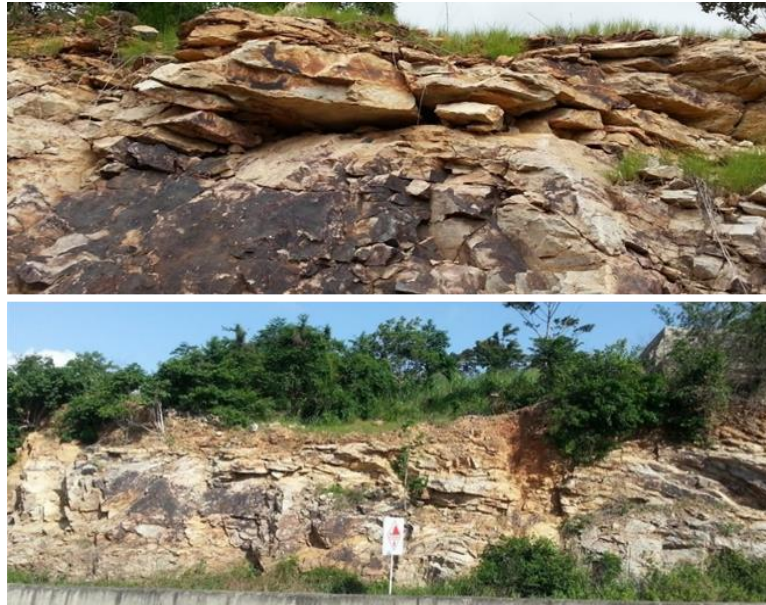
**Figure 5. Slope face of RS11**

The total RHRS scores ranged between 185 and 429. The findings from the evaluation of these sites implied that RS11 with the highest score of 429 was the site most likely to fail along the road.

The Akwapim-Togo Range has undergone intense folding, faulting and fracturing. Further physical disturbance of the geology of the area influences of rock falls. For this reason, the Ministry of Roads and Highways could consider including stabilization of slopes to any intense construction activities along slopes of appreciable height. Engineers could also consider removing weathered rocks with hydraulic rock hammer to clean these features off slope faces sites which failed after the installation of the wire. Preferably, the spraying of fibrecrete on slope face could be considered since it will maintain and enhance the aesthetic of the slopes along the road. Also, the evaluation of sites using MCRHRS indicated that RS11 with the highest score of 429 was most likely to fail. RS11 was also assessed as a site with moderate degree of hazard and requiring higher priority of remedial works. Therefore, Ghana Highway Authority (GHA) could consider prioritizing routine monitoring and maintenance of wire mesh along RS11.

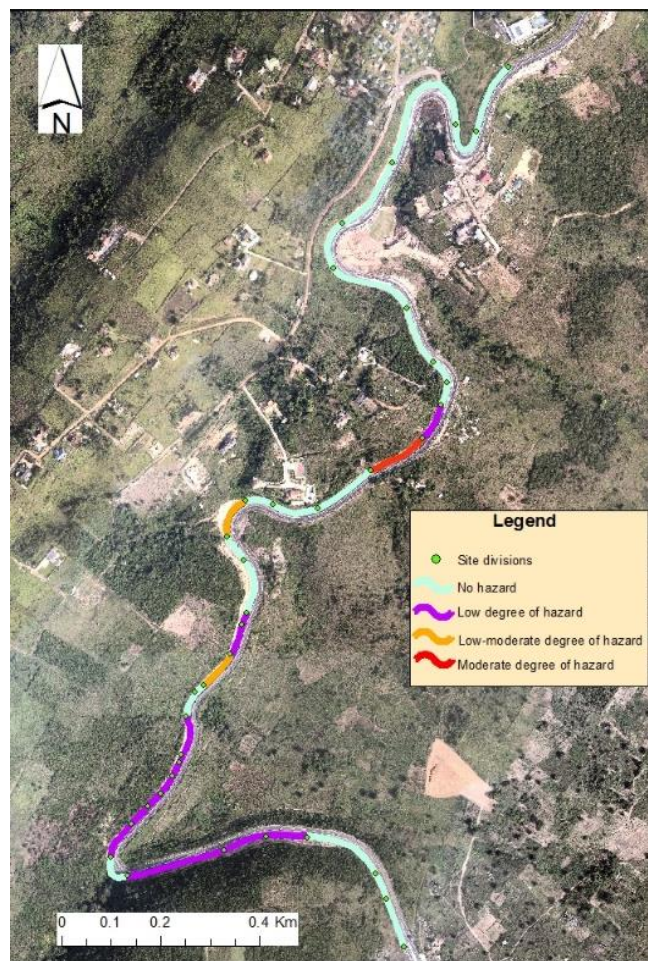
**Figure 6. Spatial Distribution of Sites with related Degree of Hazard**  
**Source: Cartography and Geographic Information System Unit,**  
**Department of Geography and Regional Planning, University of Cape Coast (2016)**

As shown in Figure 6, road segment along RS11 indicated with red was classified as section requiring higher priority of remedial works. Also, road segments along RS15 and 20 indicated with yellow were classified as segments whose remedial works are worth given high priority. Furthermore, road segments along 13 sites indicated with purple were classified as segments whose remedial works require low priority. The remaining segments indicated with a shade of green may currently not require any remedial works since rock falls are not likely to occur along these slopes.
